# Groove Mechanical Connectors Show Better Erosion/Corrosion Resistance with Copper Piping than Sweated Joints

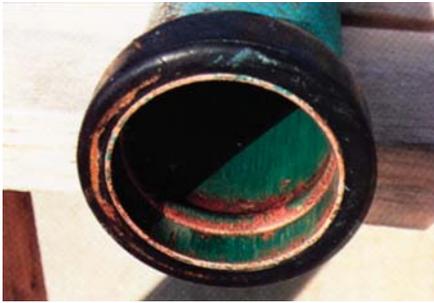
**Figure 2**

Appearance of copper pipe at upstream roll groove after 30 days in natural seawater.

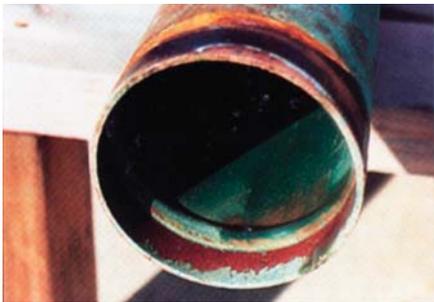
**Figure 3**

Appearance of copper pipe at downstream roll groove after 30 days in natural seawater.

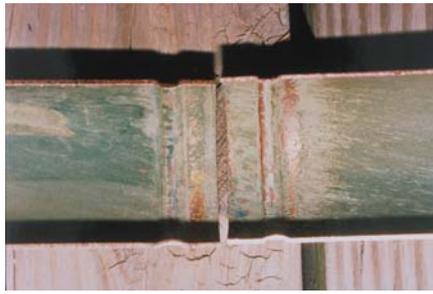
**Figure 5**

Appearance at roll grooved area after 60 days in natural seawater (flow - left to right).

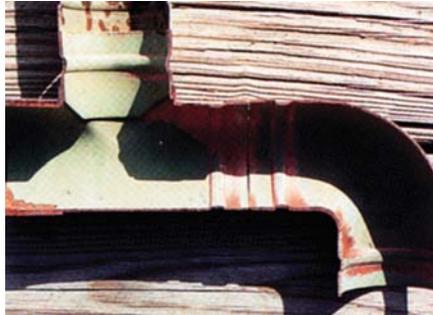
**Figure 6**

Appearance of the inside of the tee/elbow combination after 60 days in natural seawater (flow - left to right).

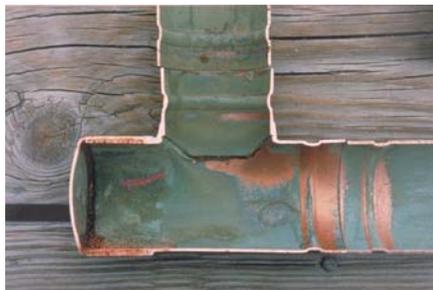
**Figure 7**

Appearance at roll grooved tee after 60 days in natural seawater (flow - left to right).

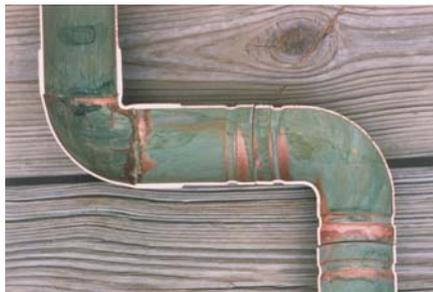
**Figure 8**

Appearance of sweat elbow and roll grooved elbow after 60 days in natural seawater (flow - left to right).

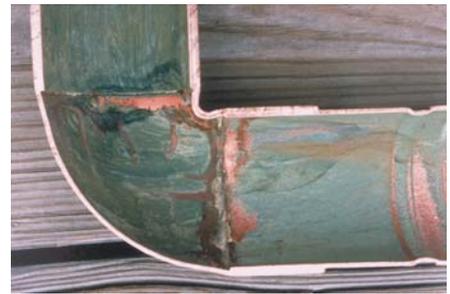
**Figure 9**

Only one site of measurable localized attack, as shown in Figure 9, was found. This localized erosion corrosion, measuring 10 to 15 mils in depth, resulted from excess solder deposits left on the inside diameter from the sweating operation.

Close-up appearances of sweat elbow after 60 days in natural seawater. The depth of attack is approximately 10-15 mils (flow - left to right).

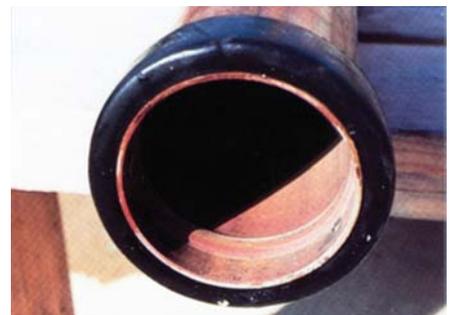
**Figure 10**

As in the seawater test system, the potable water system was partially disassembled and inspected after 30 days of testing. Photographs taken during this inspection are shown in Figures 10 – 11. This inspection indicated that there was no visible attack and that an adherent corrosion product film was in place.

Appearance of copper pipe at upstream roll groove after 30 days in potable water at 150°F/66°C.

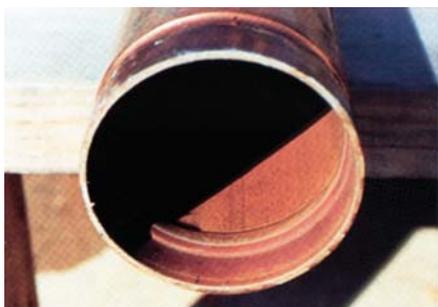
**Figure 11**

Appearance of copper pipe at downstream roll groove after 30 days in potable water at 150°F/+66°C.

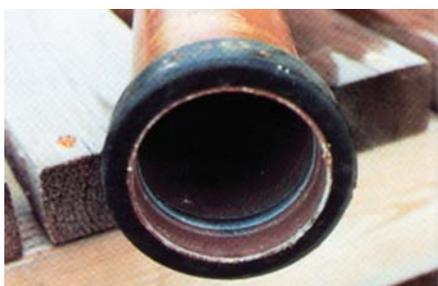
**Figure 12**

The next inspection of this system was performed at 60 days and the photographs in Figures 12 – 14 show that little, if any, change had taken place since the 30 day inspection.

Appearance of copper pipe at upstream roll groove after 60 days in potable water at 150°F/+66°C.

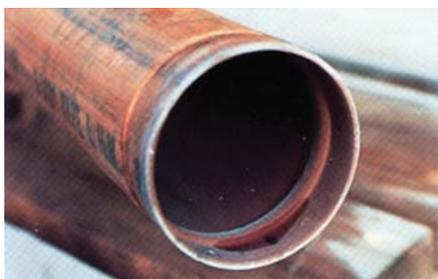
**Figure 13**

Appearance of copper pipe at downstream roll groove after 60 days in potable water at 150°F/+66°C.

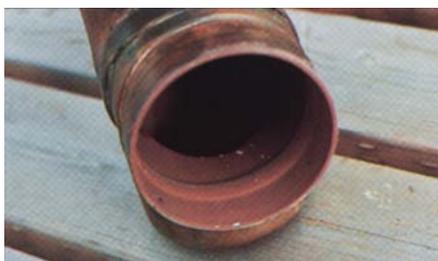
**Figure 14**

Appearance of roll grooved area in tee/elbow combination after 60 days in potable water at 150°F/+66°C.

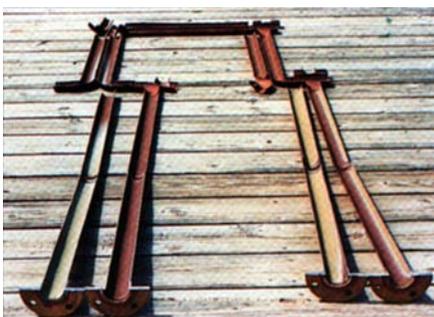
**Figure 15**

Overall appearance after six months operation at 6 ft./sec. in 150°F/+66°C potable water.

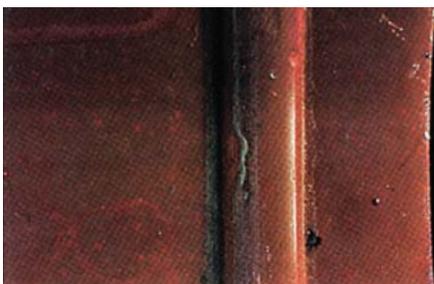
**Figure 16**

At the conclusion of the six month test period, the system was shut down, disassembled, and the test sections were split longitudinally. The overall appearance of the inside diameter of the system is shown in Figure 15. Close-up photographs of the higher turbulence areas are shown in Figures 16 – 19. As can be seen in these photographs, there are no signs of any attack associated with the roll grooves.

Typical appearance of roll grooved area in copper pipe after six months' exposure to 6 ft./sec. potable water at 150°F/+66°C.

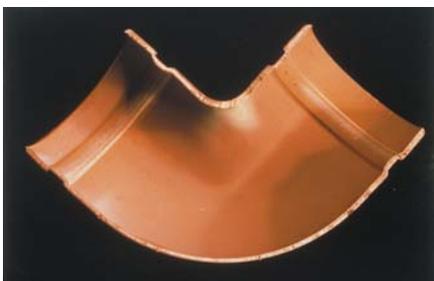
**Figure 17**

Appearance of roll grooved elbow after six months' exposure to 6 ft./sec. potable water at 150°F/+66°C.

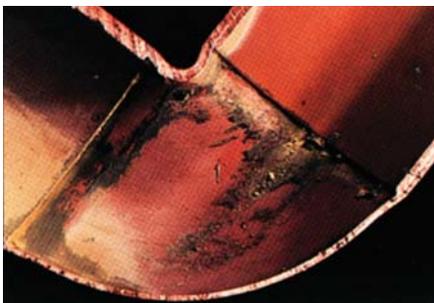
**Figure 18**

Appearance of sweat elbow after six months' exposure to 6 ft./sec. potable water at 150°F/+66°C.

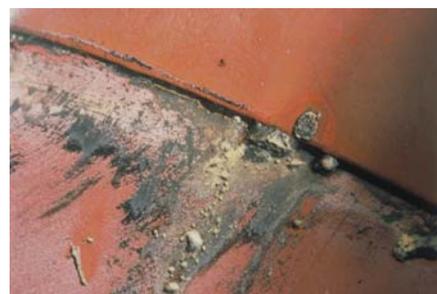
**Figure 19**

Close-up of sweat elbow after six months' exposure to potable water at 150°F/+66°C.

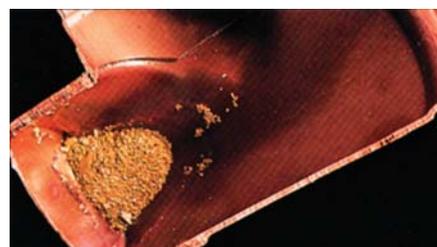
**Figure 20**

The fully developed corrosion product film was affected at only one place. This location, as shown in Figure 20, was at the bottom of the sweated cap on one of the tees. This area was the low point within the test piping section of the system and apparently the highly abrasive carbonate material precipitated from the potable water collected in this location was continually swirled. This swirling action kept the copper from developing its naturally protective film (or continually abraded it away) and caused the accelerated corrosion observed here. The carbonate material found in this system is typical of heated Wrightsville Beach municipal water and is due to the high (650 - 750 ppm) total dissolved solids content. The depth of this attack is approximately five mils.

Appearance of attack caused by carbonate material in bottom of sweated tee cap (depth of attack five mils).

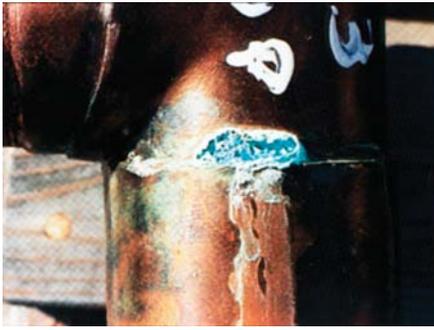
**Figure 21**

Appearance of corrosion product buildup on exterior surface of sweated joint after approximately six months.

Upon inspection of the outer surfaces of this system, there was only one location that displayed signs of localized corrosion. This attack, shown in Figure 21, was apparently caused by the acid based flux used in the sweating operation.
